BRITISH MINING No.11

Landless, V. 1979 "Greenside explored"
British Mining No.11, NMRS, pp.66-74

GREENSIDE EXPLORED

by V. Landless.

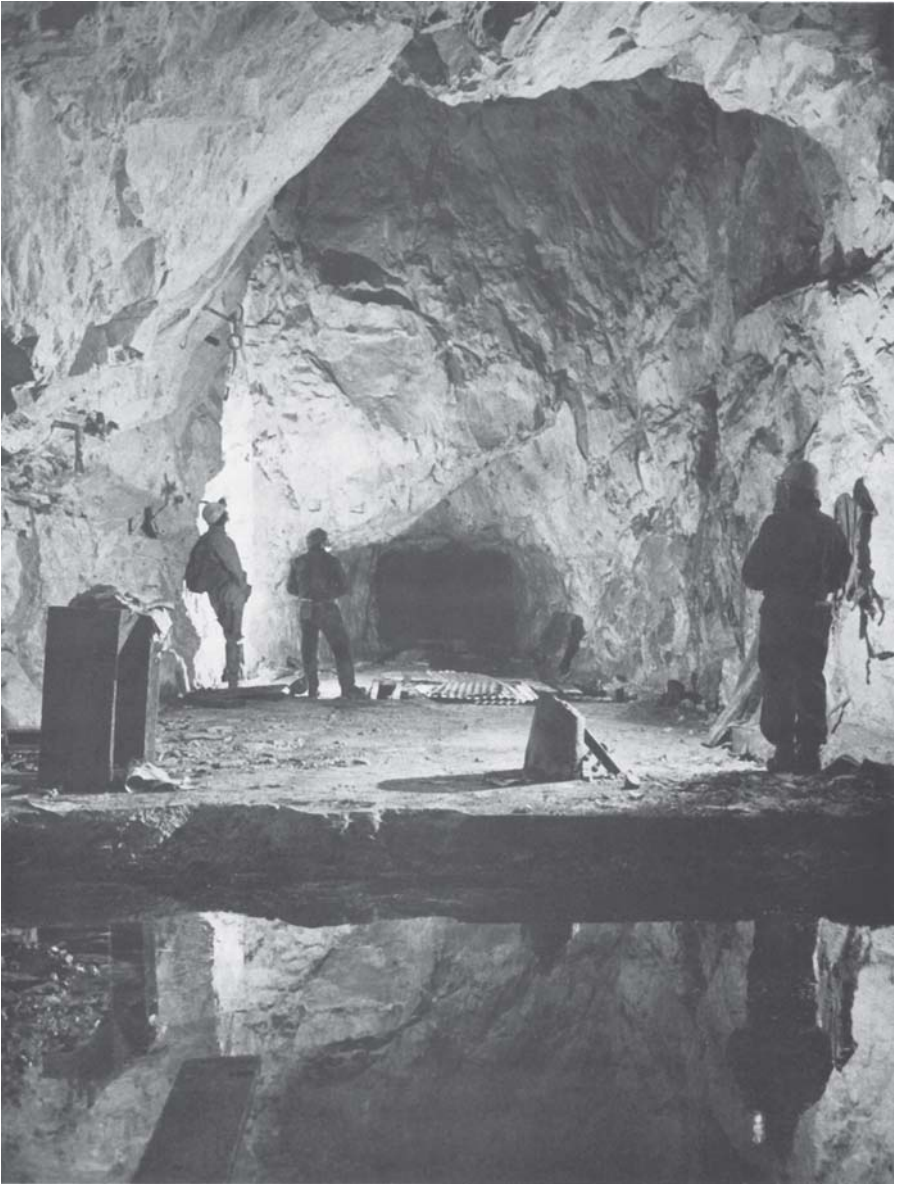
PLATE I. GREENSIDE MINE. ENGINE ROOM AT COLLAR OF SMITH'S SHAFT, LUCY TONGUE LEVEL. THE SHAFT IS BENEATH THE CORRUGATED SHEETS (CENTRE) AND IN THE FOREGROUND IS THE FLOODED WINDING ENGINE EMPLACEMENT. (PHOTO: R.H.B.)

The headgear for Smiths Shaft, which is covered over in the centre of the chamber, was housed here. At the far end is the sump for the winding engines, now full of evil brown water. The walls have been whitewashed for better illumination. Various tools and miscellaneous objects, like oil cans and sweeping brushes are still here, and there are also two leather safety helmets and remains of a jacket hanging on pegs. All traces of the winding and pumping gear have long gone. The shaft itself, which went down to 90 fms. was equipped with the first electric winder to be used in a metal mine in Britain (1896).

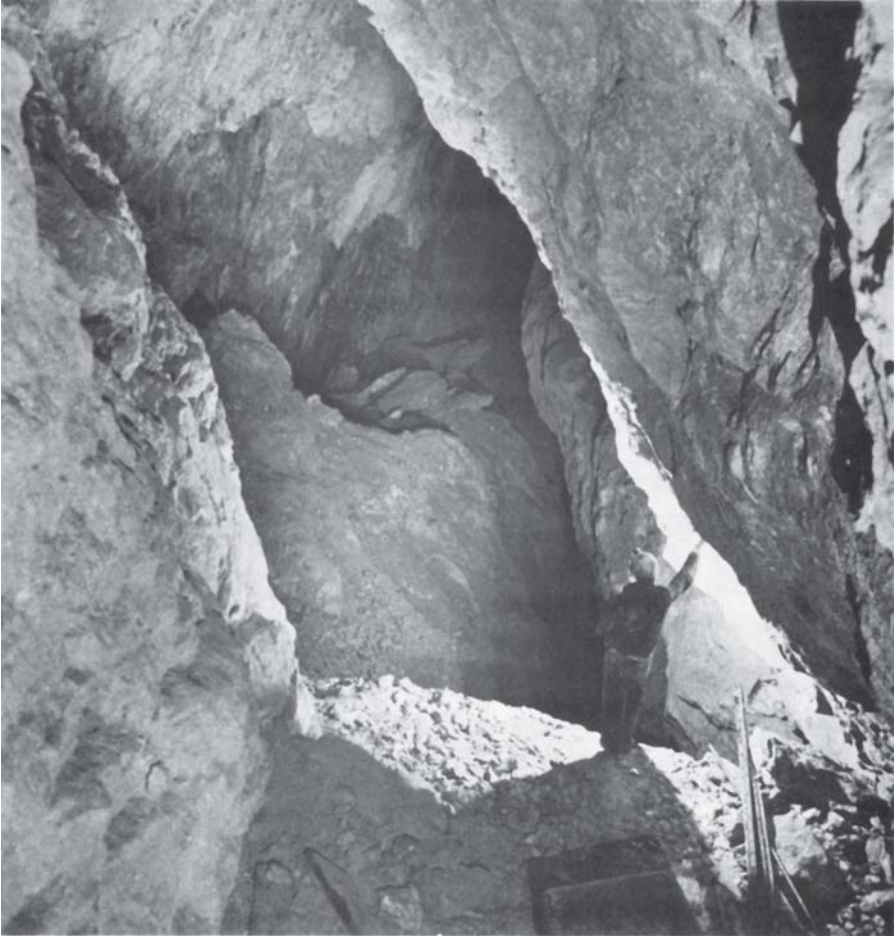
PLATE II. PART OF THE HUGE STOPES AS SEEN FROM THE LADDER ROAD. (PHOTO: R.H.B.)

The 36 fathom level is reached next. Its length can now be measured in about 75 paces to the forehead, as southwards nothing but a vast chasm remains. Into it have been dumped deads etc., which slope away at 30° into blackness. These stopes extend

over such a large area that in 1936 when the mine was changing hands a report stated:- “The point I wish to bring out is that there exists in the mine great stoped-out chambers, separated by somewhat soft and yielding rocks, that these empty stopes have great vertical dimensions, being one above the other, and that there is surface evidence in the form of recent fissuring of the rock, of the instability underground. It would seem therefore, that below the deepest workings a certain thickness of ground should be left unworked”.

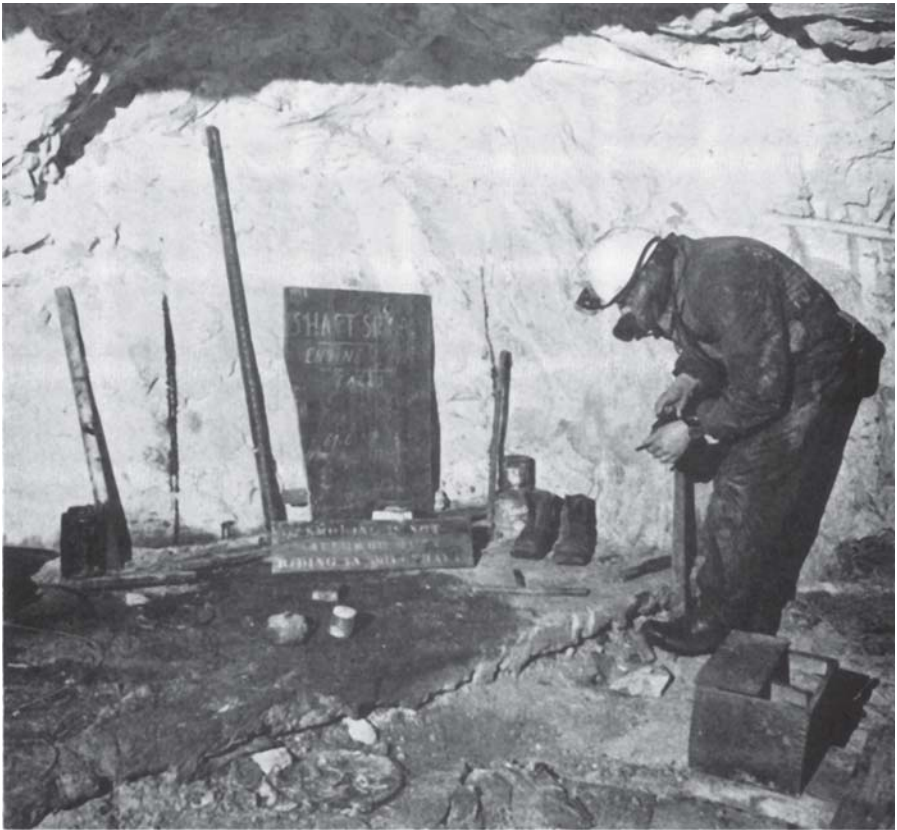
PLATE III. VARIOUS ARTEFACTS IN THE ENGINE ROOM, SMITH'S SHAFT. (PHOTO: R.H.B.)

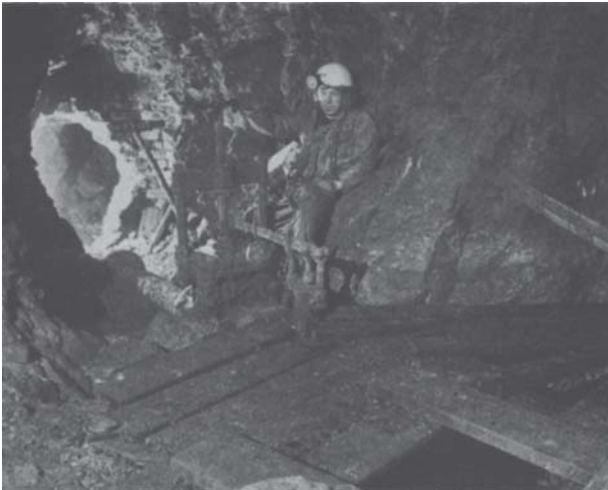
PLATE IV. GREENSIDE MINE. THE STOP AND BLOW-OFF VALVES AT HEAD OF CLIMBING WAY, HIGH HORSE LEVEL. ONE OF THE BREACHED DAMS IS VISIBLE TO THE LEFT. (PHOTO: R.H.B.)

This area is of interest as it is from these upper workings that water was drawn to power a hydraulic engine used for pumping and winding in the lower sections of the mine. In order to accumulate sufficient quantities of [66] water, dams were built to seal off various areas. The remains of them are plainly seen around here. The reason for access being possible through this part of the mine – an area that became worked out and abandoned nearly 100 years ago – lies in the Mines and Quarries Act, and states that at least two exits must exist from a mine. The only feasible route was up through the stopes and out of Glencoyndale. The old disused dams were therefore holed through (no mean task as they consist mainly of white brick up to 18" in thickness) and new ladderways installed. It can be observed from the accompanying diagram that there were three brick dams and one iron curved dam, from the remains of which it appears water was stored in the northerly workings from where the pipe leads, and the other dams were built as a safeguard to prevent water entering the lower workings should the main dam fail. As to the reason for an iron dam, (incidentally, the only one actually marked on the old plans) is not wholly clear. One possible explanation is that this was the original, but the blockage shown, which contains some large slabs of rock, prevented its successful operation continuing. Questions still remain unanswered, such as the use of the aperture one third the way up, which is just too small to get through easily and also whether there was other pipework connected with this dam going southwards instead of down the rise in the chamber. Another dam of similar construction is to be found in the Low Horse Level below and this was used at a later date for the same purpose.

There is an on/off valve and a pressure valve situated at the top of the pipe before it descends the rise. The pipe diameter is approximately 10 ins. and where it is fractured near to the top, has a wall thickness of $\frac{3}{4}$ inch.

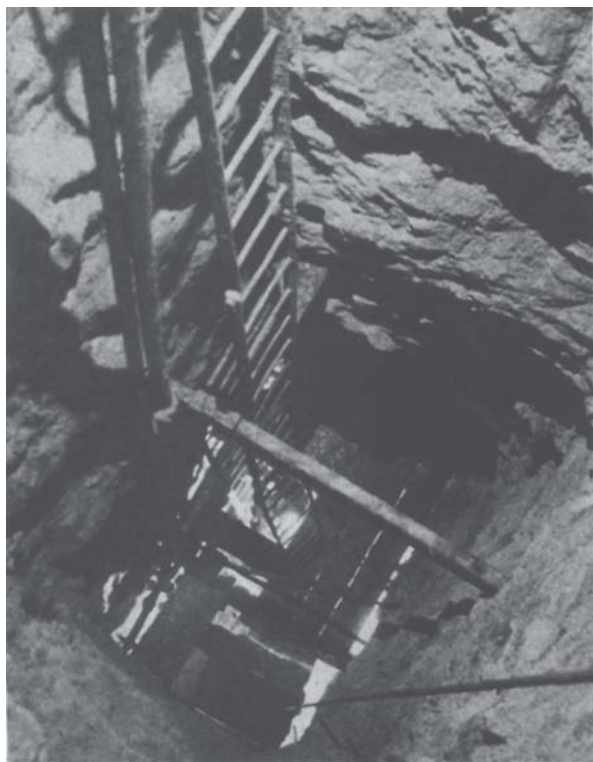
PLATE V. LADDER ROAD IN THE HAULAGE-WAY NEAR ADIT LEVEL. (PHOTO: R.H.B.)

Down the ladders again on the next and final leg to the Lucy Level. Most of the descent is through a haulage way and therefore of bigger dimensions than the previous rise. Considerable timbering has been used in this area for staging, shuttering etc., and at one point near the bottom there is an impressive construction on the left side, consisting of huge steel girders on which have been laid large sections of timber to a height of maybe 10 feet but its purpose is unknown. Part-way down, at the top of one ladder is a signalling clapper made up of a large pivoted hammer above which is a metal plate. A wire connects with the hammer shaft and when pulled from below would give the required number of knocks for lowering or raising a kibble in the shaft. The winch may have been mounted on the timbering mentioned above.

On the whole, the ladders are all in sound condition but the last 40 feet to the Lucy Level has dry rot and care is needed, in fact the very last section has fallen, so an electron ladder of the required length is needed for the final few feet.

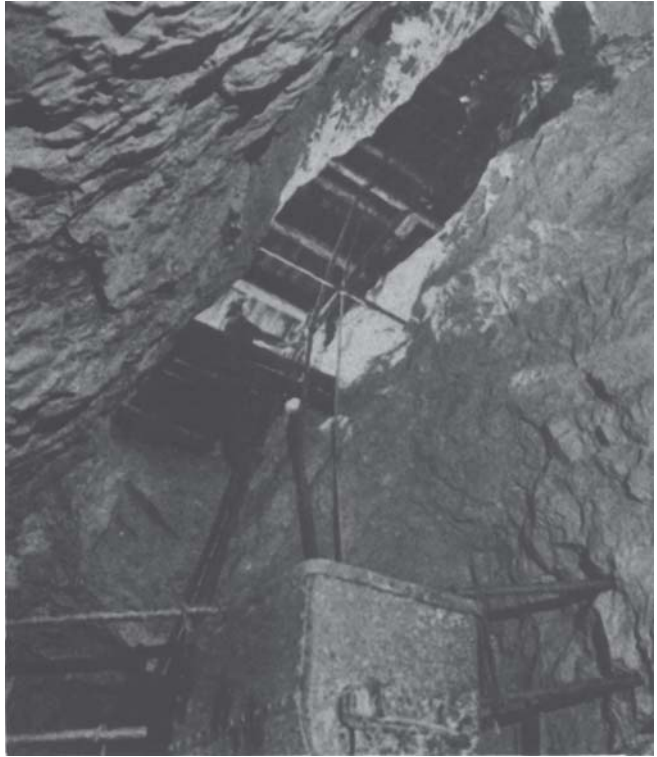
PLATE VI. LADDER ROAD THROUGH THE STOPES. NOTE THE TWO FIGURES ON THE LADDER; IT WAS FROM THE LOWER SOLLAR THAT THE VIEW OF THE STOPE (PL.IV) WAS OBTAINED. (PHOTO: R.H.B.)
