BRITISH MINING No.19

WEST STONESDALE MINE

The following article details a brief history of the mine and describes the surface features which remain for the present day explorer.

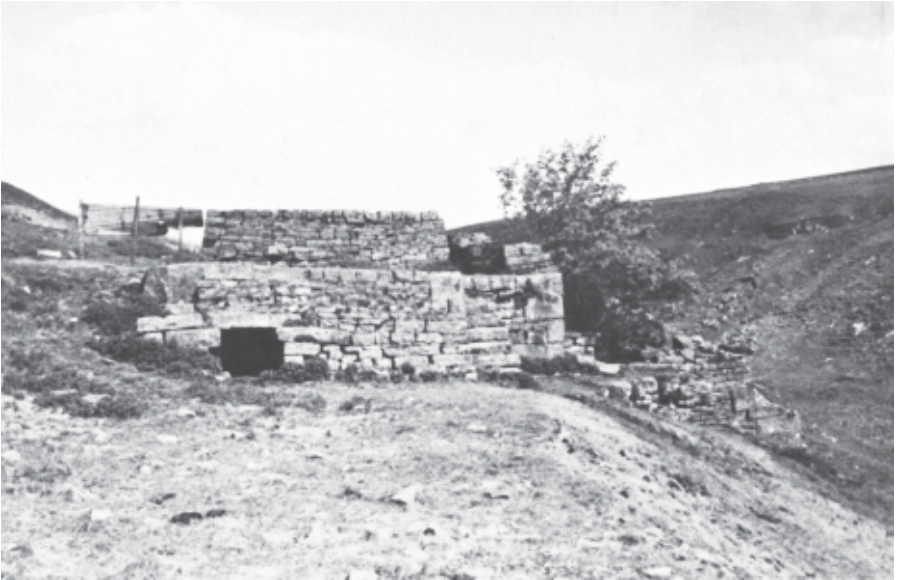
Plate 1. Shaft Top View looking north May 1980

The shaft is at present covered with railway sleepers and since the survey has been used as a dumping place for farm rubbish. Grooves cut into the stonework at the shaft top would suggest that a head frame was at one time erected over the shaft and used in hauling operations, the shaft being of ample dimensions for a small cage or kibble in addition to the pump rods and rising main.

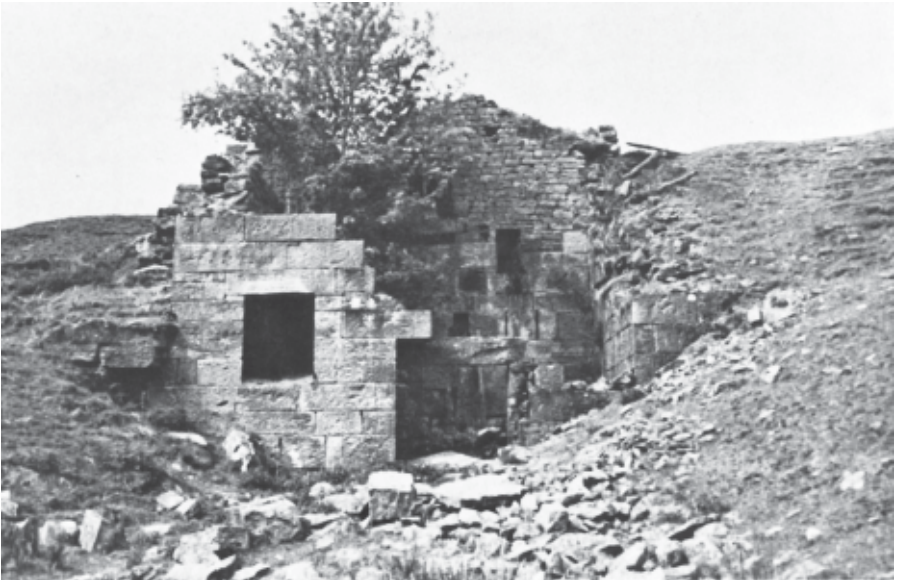
Plate 2. Engine House View looking west May 1980

The most significant building at the mine is the engine house which is situated adjacent to the shaft. This building is extremely well constructed being made from large blocks of dressed stone and is built into the side of the hill. The house itself is divided into two parts; the right hand (northerly) half formerly containing the hydraulic pumping engine and the left half containing [15] the pump rods and cranks. Proceeding through an arched passage at the rear of the engine house leads to the edge of the shaft and the balance bob chamber beyond. The bob and rod chamber has a shallow groove cut in the floor and a square opening let into the right hand wall.

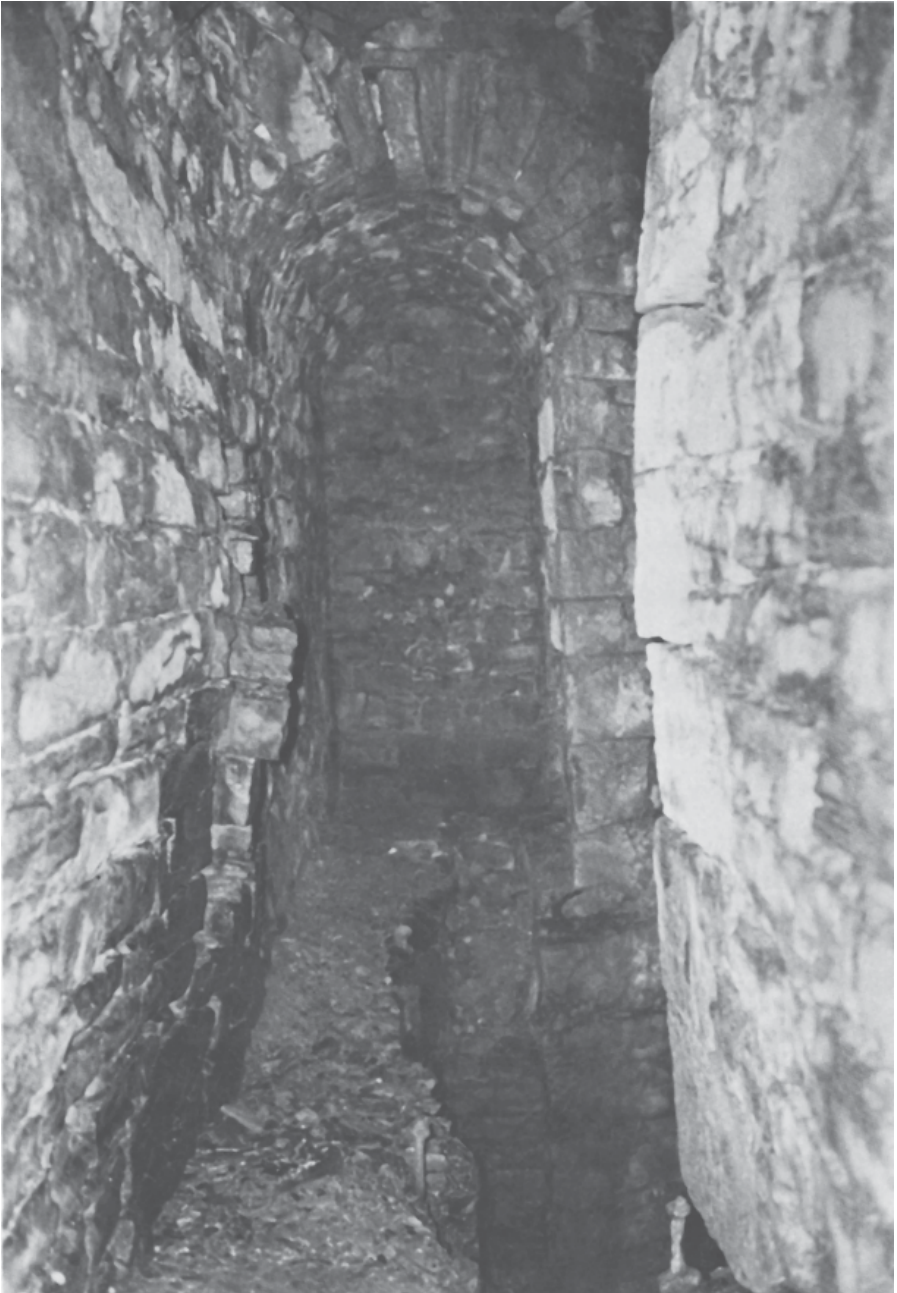
Plate 3. View of Balance Bob Chamber September 1978

At the time of the survey carried out by society members (August 1976) the water stood to within 38 feet of the shaft top (10 feet 8 inches from the floor of the bob chamber). During subsequent visits to the site the water level was found to be lower and on these occasions it was possible to see the rising main in the shaft. The shaft itself is approximately 9 feet in diameter, varying slightly, and is stone lined to at least water level.
