Fairbairn, R.A. 1999
"Allen Mills Flues and Chimneys"
British Mining No.63, NMRS, pp.141-146

ALLEN MILL FLUES AND CHIMNEYS

by Raymond A. Fairbairn

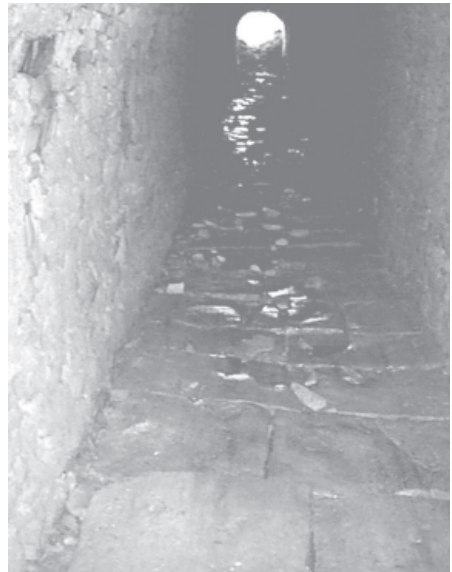
Sections of the flues have been demolished for stone or to recover land. The best preserved sections show that the cross section was as in Plate I (Cleugh Head NY81925544). Entrances, measuring 1.0 metre by 1.8 metre, were built into the flue to allow the flue dust to be removed. They were not spaced at precisely equal intervals, the distance between them averaging 270 metres, but varying between 180 and 310 metres. At two places (NY81685518 and NY81825395), where an entrance has been built, an enlarged section of flue has been constructed. The former entrance to the west flue, by the side of the road near Frolar Meadows, has recently had the arching of the enlarged section removed and been consolidated to allow viewing. Most of the entrances have ready access to a road, in one instance (NY81505495), where the flue has diverged from the road system, the entrance has been constructed as a tunnel from the boundary wall to the flue. The reason for the tunnel was almost certainly to prevent contamination of the pasture with flue dust.

Plate I. Flue near Cleugh Head (Fairbairn, 1994).

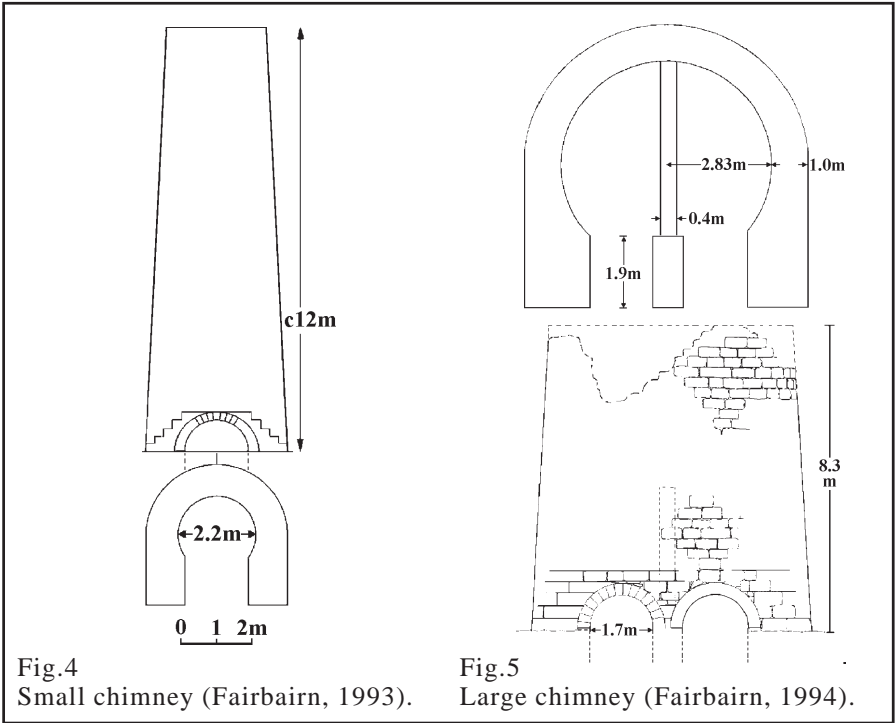
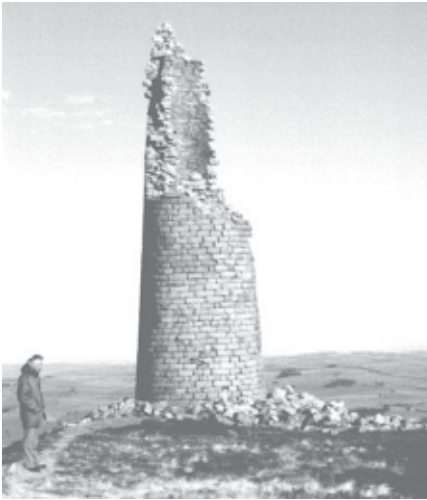
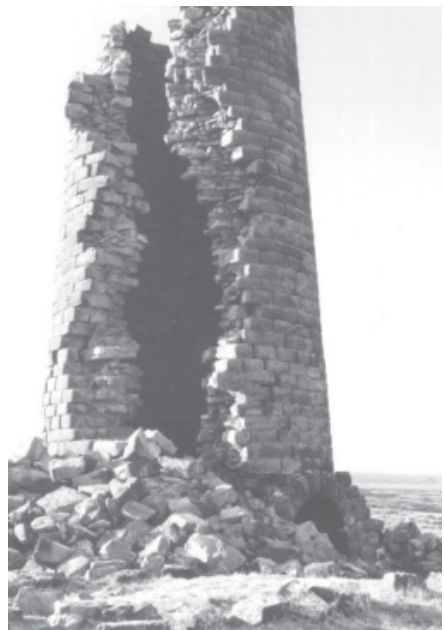
Plates II & III The small chimney after the collapse (Fairbairn, 1994).

The small chimney (NY80975398) has an internal diameter of 2.2 metres and was about 12 metres tall (Figure 4). The upper third of the chimney developed a list over the years and in 1994 it collapsed during a storm. It was said to have been struck by lightning, but the collapse was probably because of instability, caused by the list and helped by the lubrication of the downpour (Plate II). The North Pennines Heritage Trust rebuilt the chimney and retained as much of the original structure as possible.

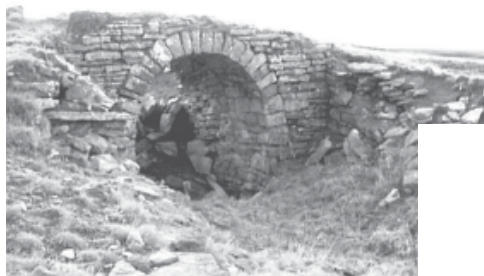
*Plate V Enlarged section of flue
at NY81825395 (Fairbairn, 1995)*

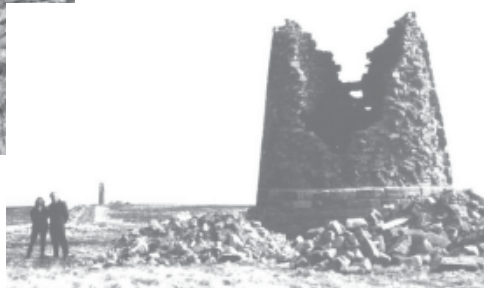
The large chimney was in a ruinous state in 1994. Judging by the quantity of materials lying about the site, it had never been any higher than when measured in 1994 (Figure 5). It had an internal dividing wall which extended half-way up the chimney and separated the gases from the two flues.

*Plate IV Large chimney during
re-building NY80735367
(Fairbairn, 1995)*
