British Mining No.73, NMRS, pp.72-88

**AN INITIAL SURVEY OF BOOZE WOOD LEVEL,
ARKENGARThDALE, NORTH YORKSHIRE,
JULY 2003**

By Alan Mills, with Paul Dollery,
Malcolm Needham and Richard Platt

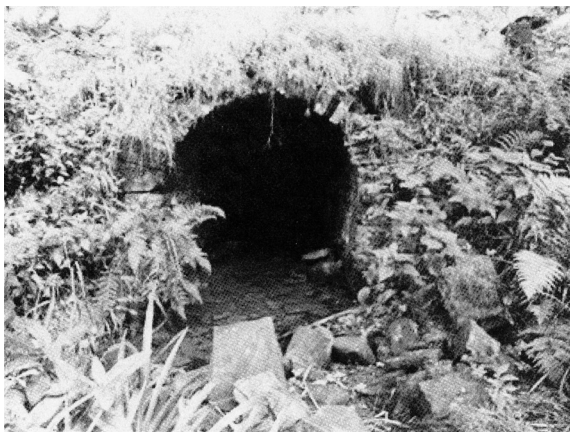
Plate 1. Booze Wood Level portal.

Booze Wood was a 19th Century lead mine, later used as a source of building stone. The mine is located in the Yorkshire Dales National Park, approximately 1km south-east of the hamlet of Lanthwaite, on the north side of the Arkle Beck. The level's portal is at NGR NZ 01426 01984, at an altitude of approximately 238m² (Plate 1).

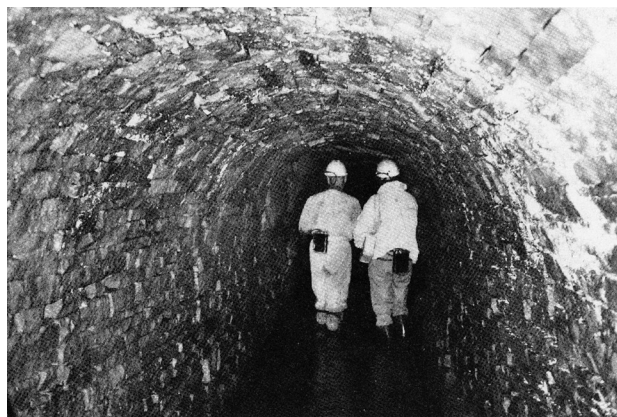
Plate 2. Surveyors between stations 3 and 4

As previously stated the level is driven at a bearing of 5° magnetic. The level is fully lined with dry-stone arching for the first 40m (Plate 2). It then enters sandstone and thin shale beds; this is the predominant geology for the currently accessible parts of the mine. Thereafter there is a mixture of no arching, full arching and half-arching supported on pegs and rails (Plate 3).

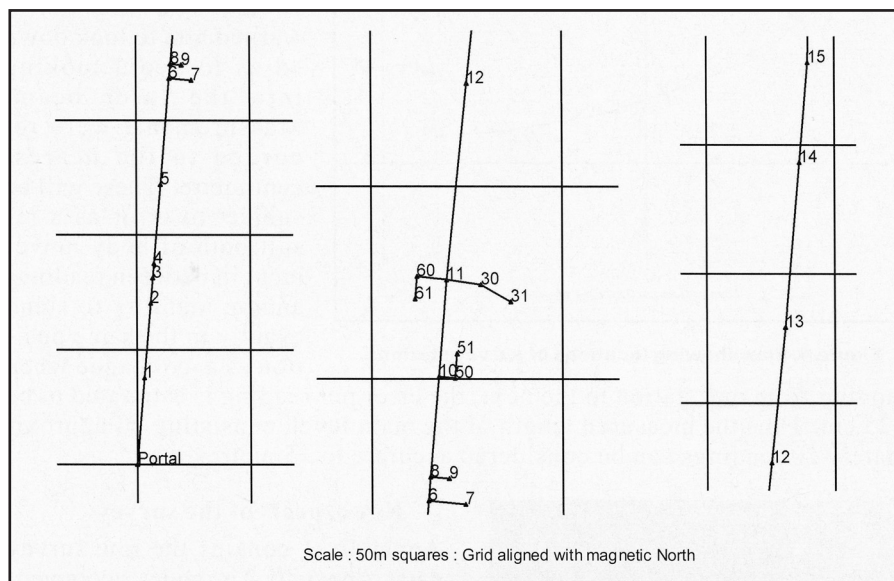
Figure 3. Booze Wood Level plans showing locations of survey stations.

Appendix 1 contains the raw survey data. Appendix 2 provides a commentary on the geology, structure and artefacts of Booze Wood Level. Figures 2, 3 and 4 show the plans of the level as surveyed, with station numbers identified.

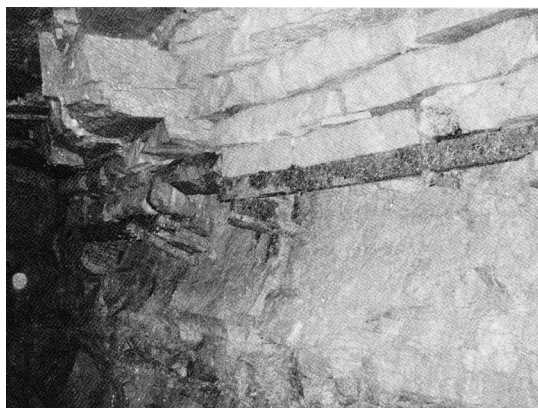
Plate 3. Iron pegs holding up rail.

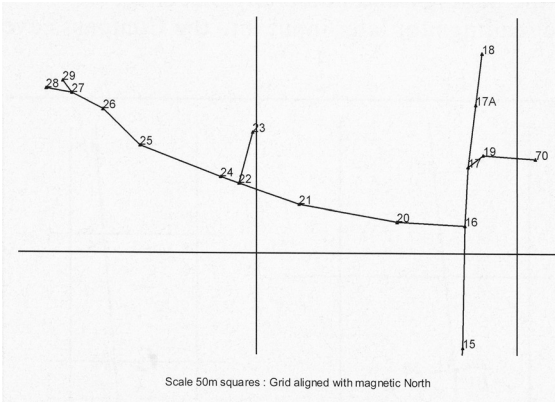
Figure 4. Plan showing locations of survey stations.

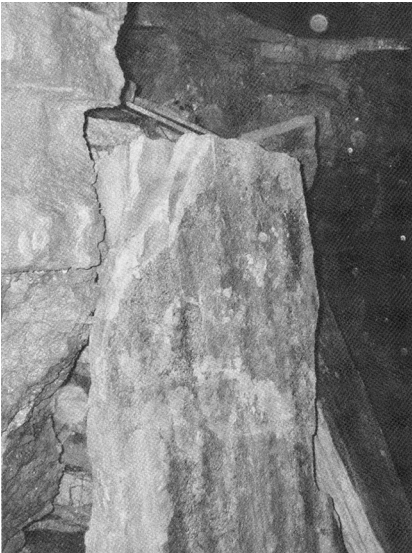
Plate 4. Ripple stone near station 8.

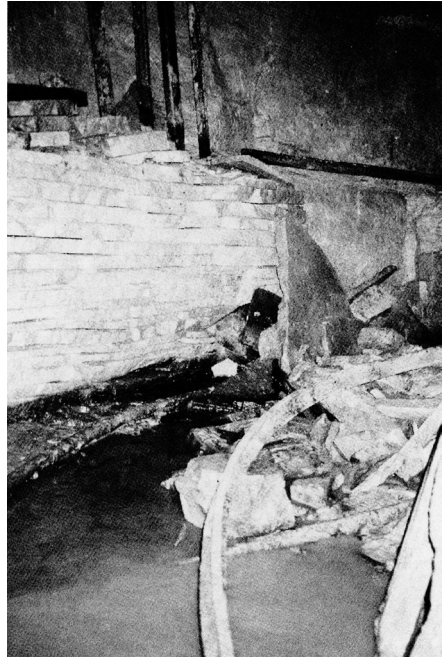
Plate 5. Survey station 11.

The major workings for stone are off to the right (east) at station 11. At this station there are rails in-situ and further rails stacked against the wall (Plate 5). These major workings were not fully surveyed. They are complex with few straight sections. There are a

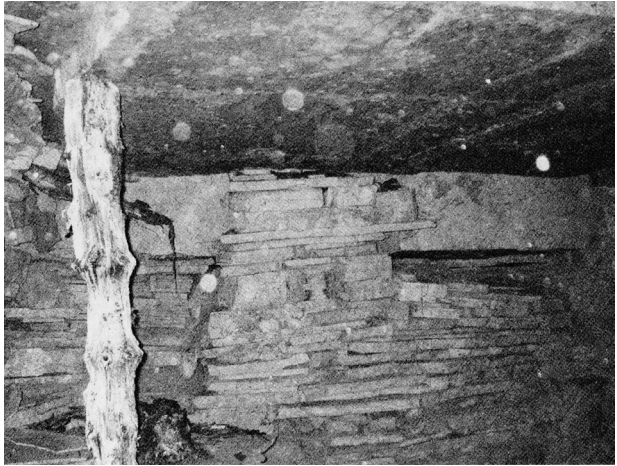
Plate 7. Roughly worked roof support.

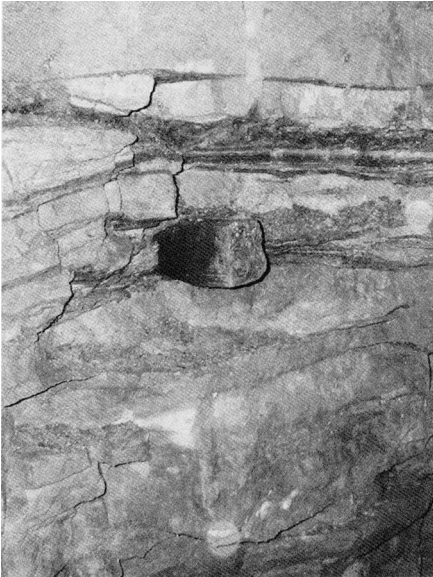
Plate 8. Wooden peg.

approximately 1m high. This was presumably put in place to signify that the old workings were "out-of-bounds" once the focus of mine changed to extracting stone rather than lead. Beyond station 11 the level continues through sandstone principally, with thin shale beds. There are several wooden pegs in the wall between stations 13 and 14 (Plate 8), the purpose of which is unknown.

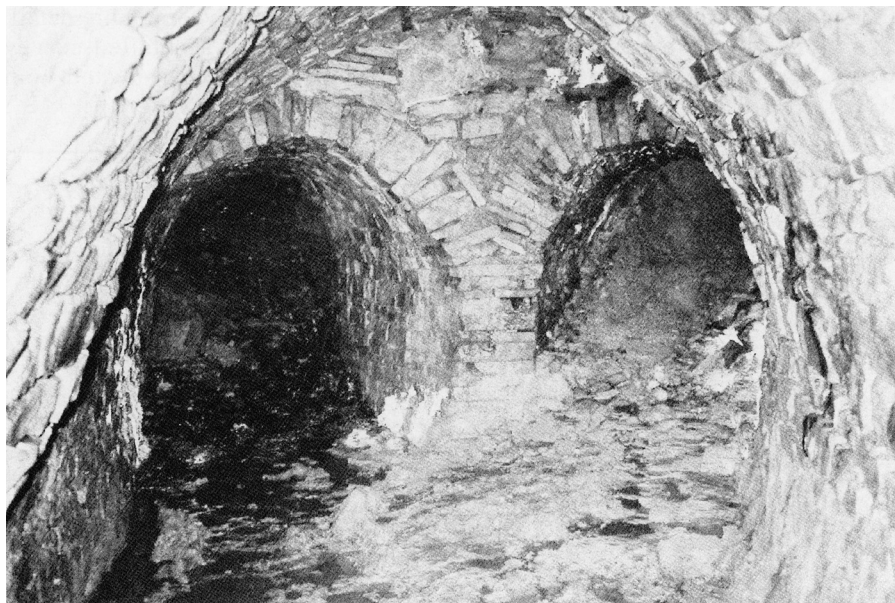
Plate 9. Survey station 27.

Returning to station 22, the passage continues westerly, entering a section where the dry-stone arching is initially supported by rails on pegs (station 24) and which then turns into full drystone arching beyond station 25; the arching becomes compressed on the left as the dry-stone arched junction (station 27) is approached (Plate 9).

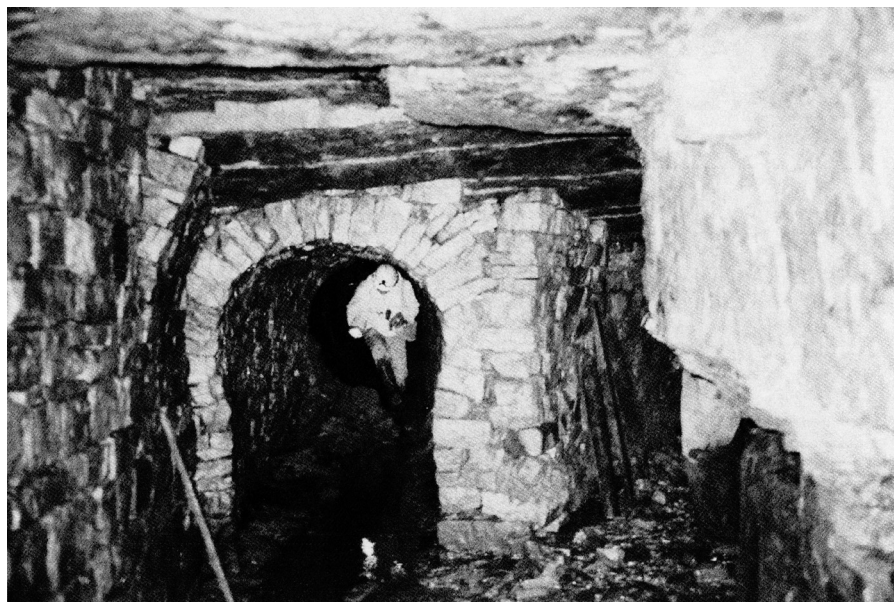
Plate 10. Survey station 17.

Returning to station 16, the level continues northerly for 11m to an arched junction at station 17 (Plate 10). The right-hand passage has full dry-stone arching and curves away to the right, with a rising floor leading into deep water. This section was investigated no further since by this time the survey team was cold and the water was approximately 1m deep (and cold!). Apparently Booze Wood Level once connected with Scotts Level,¹⁴ also known as Roger Level,¹⁵ in Sleil Gill. On 31st August 1883, George Stones entered into an agreement with the Arkengarthdale Mining Company to “raise ore in R Scotts old level Booze....and.... for opening level to Booze Wood so their work may be dressed at Booze Wood dressings”.¹⁶ It is possible
