Bird, R.H. 1974  
"Notes on the Rockley Mine"  
Memoirs NCMRS, Vol.2 No.4, pp.175-178

## NOTES ON THE ROCKLEY MINE

R.H. Bird

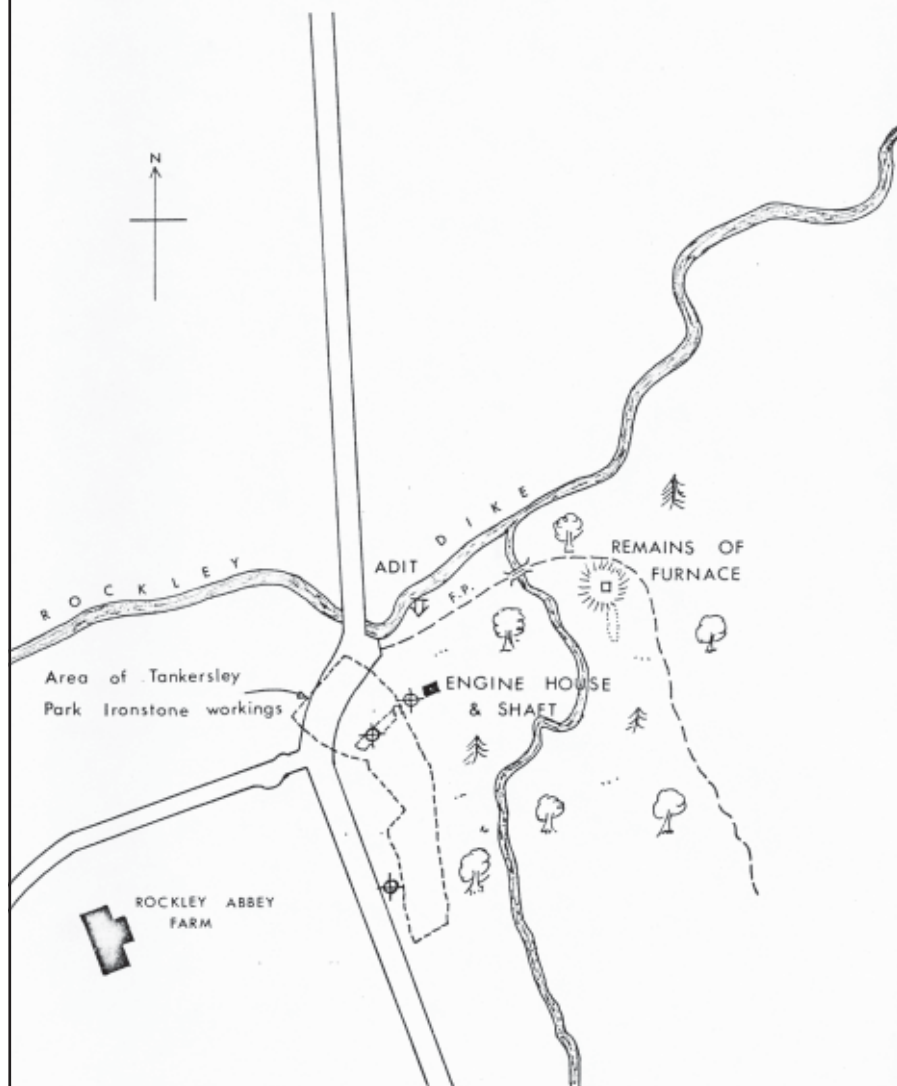
# ROCKLEY MINE , Birdwell

The Rockley engine shaft was concreted-over some years ago. Measurements taken before this found that it was ten feet in diameter and lined with stone. At a depth of 14 ft. 6 ins. from the collar there is an inset which gives access to a small pumping adit which has its outlet in the south bank of Rockley Dike. This portal is a small square opening about 18 inches high and flagged with gritstone blocks. When the engine was working the water would be discharged into this adit instead of lifting it to grass. The shaft is very likely flooded to this horizon as water escapes from the adit during sustained wet weather.

Plans in the care of the N.C.B. reveal that the shaft is deeper than early references suggest. It is, in fact, sunk to a total depth of 171 feet. At this depth it cuts the Flockton Thick coal seam although there is no evidence that this was ever worked at the mine. Such a depth would only be necessary to provide a sump for pumping purposes. To the south of the engine shaft are two further shafts which have both run-in. These may

The Rockley mine is situated about one mile NNW of the village of Birdwell near Barnsley, at NGR SE337021. The engine shaft collar is at 234 ft. OD and the underground workings occupy an area some  $\frac{3}{4}$  of an acre in extent, near the confluence of the Rockley and Warren Dykes. The engine house may be seen from the M1 motorway in the trees to the left when travelling north.
